Manhole Inspection Summary

Manhole # S04II2001MH

Insp Date: **8/9/06 12:00 AM**

Location Address: **3301 BONNIE RD**

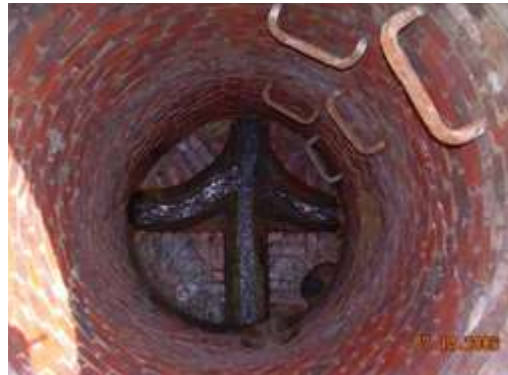
Top View

Adjustment and Barrel infiltration.
Corroded steps. Bench debris.

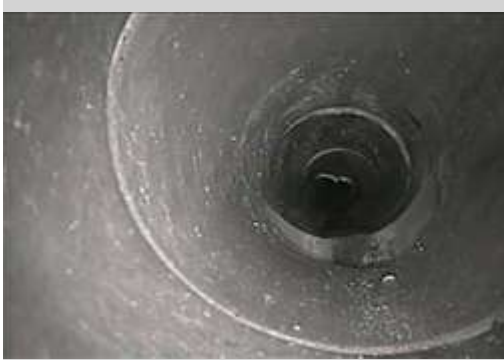
Inside of the I6

Possible broken pipe - (4th joint)

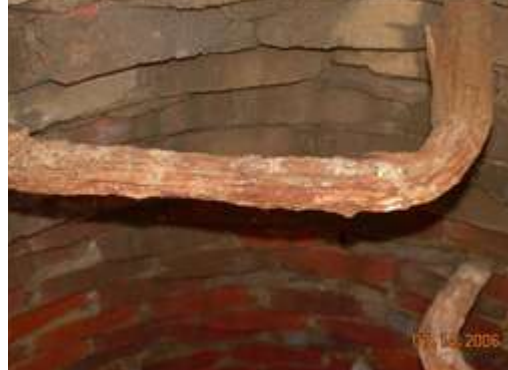
Defect

Corroded steps.

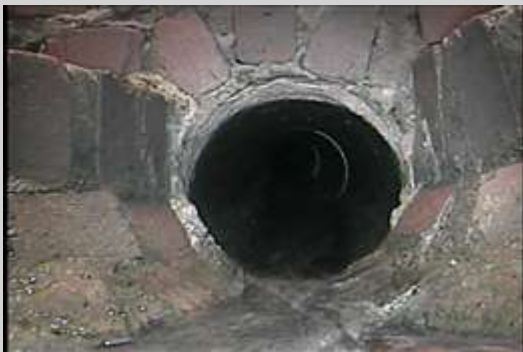
8 in. Circular Gravity Sewer Pipe Out @ 12 O'Clock

Infiltration: **Evidence** Pipe Seal Cond: **Cracked**

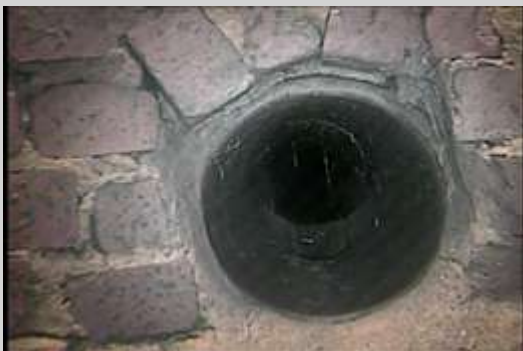
8 in. Circular Gravity Sewer Pipe In @ 3 O'Clock

Infiltration: **Evidence** Pipe Seal Cond: **Cracked**

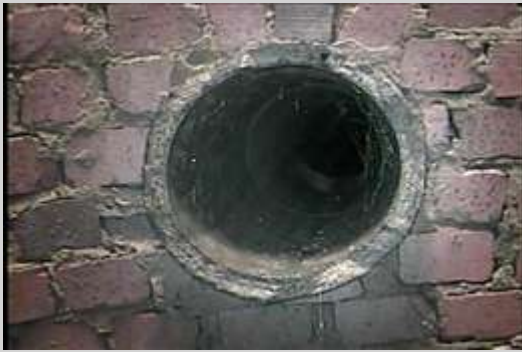
Pipe In @ 6 O'Clock

Barrel deterioration and infiltration.

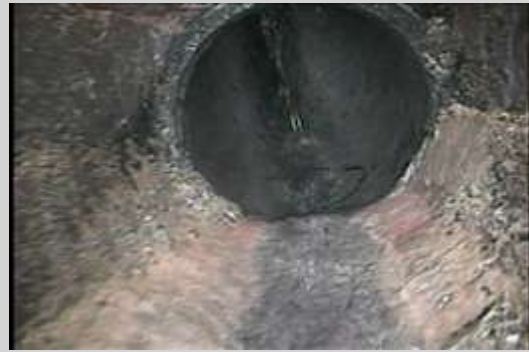
Drop In @ 6 O'Clock

Infiltration: **Evidence** Pipe Seal Cond: **Unknown**
